home-approved®

your survey report

167 [REDACTED], Muswell Hill, London, N [REDACTED]

27 March 2015

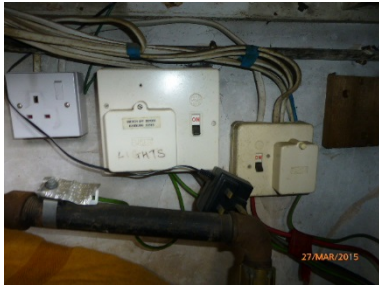
Fuse-board is dated

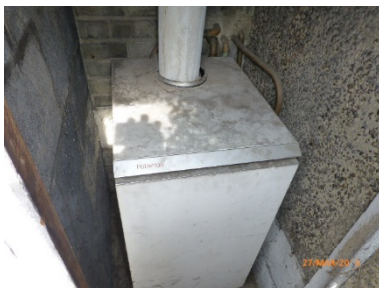
The hot water is produced by the gas fired boiler and is stored in the unlagged cylinder which is located in bedroom 5. The system is inadequate and should be updated in line with Approved Document G of The Building Regulations 2010.

Floor standing boiler

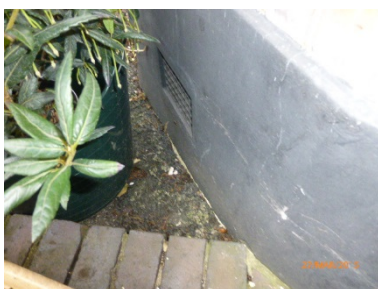
**Details/Defects/Issues:** There is a lack of ventilation to the suspended timber floor as there are only three air bricks to the front and none to the rear. The air bricks are too small and too few in number.

Small air bricks in the front wall

The existing air bricks should be increased in size to a minimum of 225mm square and additional air bricks should be installed to the rear elevations in accordance with BS 5250. Air bricks should be provided with grills to prevent entry by rodents.

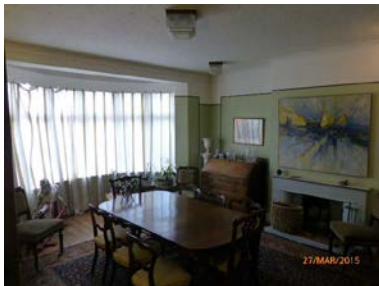
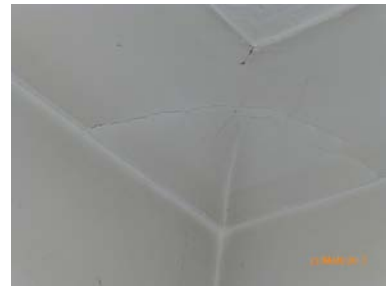
**Details/Defects/Issues:** Cracking was observed to the ceiling and the coving. There was also a small crack to the front facing bay window. None of the cracks suggest significant building movement or distortion and are more likely the result of general settlement and expansion.

Cracks to the ceiling and to the coving

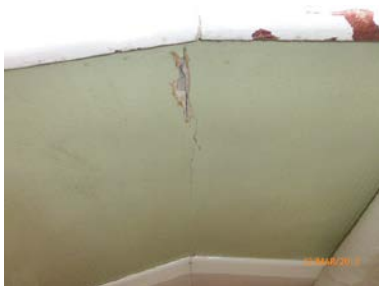
Small crack to front bay

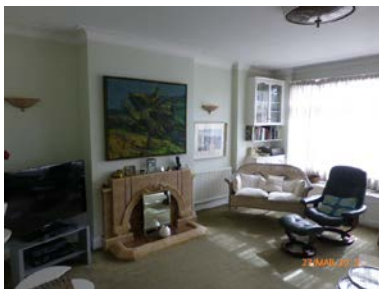
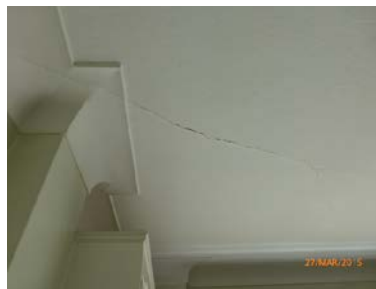
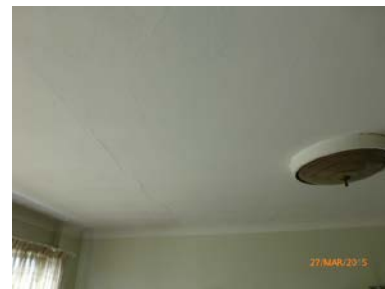
**Details/Defects/Issues:** Cracking was observed to the ceiling, coving and the walls. The cracks appeared to suggest that the rear section of the room, which is part of the single storey off-shoot, was moving outwards, however a detailed inspection both internally and externally did not reveal any further indications that the building may be suffering from movement. We are therefore of the opinion that the cracking is historical and relates to general settlement and expansion and not significant or on-going building movement or distortion. To definitively confirm the nature of any movement a programme of monitoring over a 6-12 month period would be necessary.

Cracks to the ceiling and coving

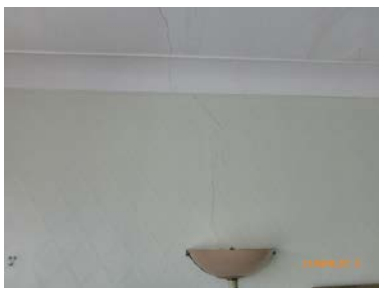
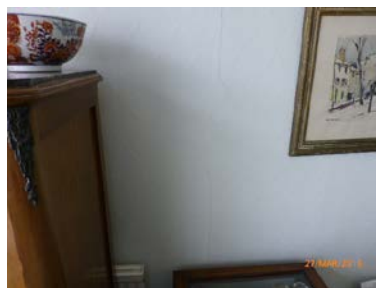
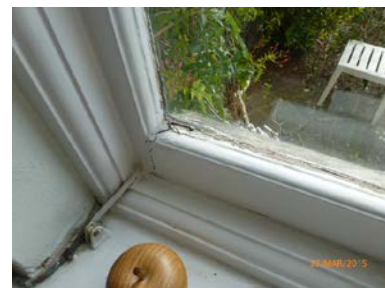
Cracks to the wall at the joint to the main building

Window decoration is poor

The decoration to the windows and rear facing door is poor and the paint is flaking and blistering. The only effective way to address the issue, if the windows are not to be replaced, is to completely overhaul the windows and door by burning off loose and defective paintwork, applying bare wood primer to any exposed timber and re-finishing in undercoat and gloss paint. Costs for this work have been separated below.

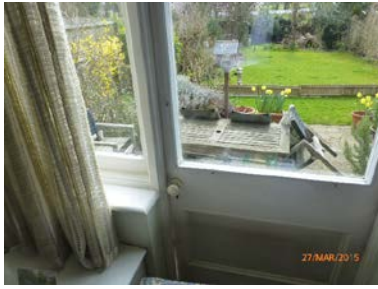
The glazing to the rear facing door and windows is not toughened. This is a safety issue and in accordance with Approved Document N of The Building Regulations 2010, glass within a critical location should be toughened with each pane carrying the British Standard reference to confirm compliance.

Glass in a critical location

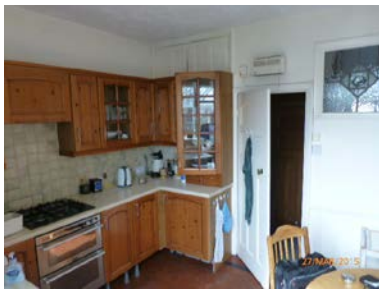
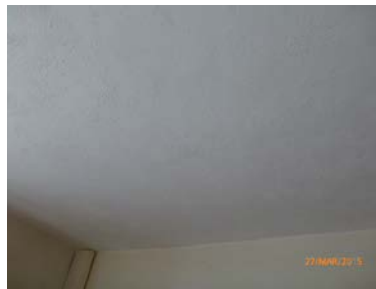
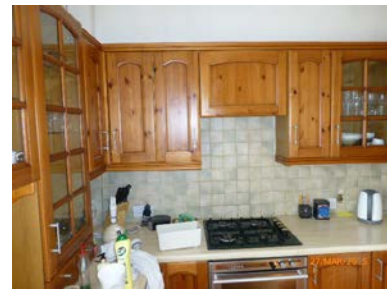
**Details/Defects/Issues:** The ceiling is covered with a textured coating which is a potential asbestos containing material (ACM). Further information in regard to potential asbestos containing materials is provided later in the report.

The kitchen comprises of floor standing and wall mounted units with free standing and integrated appliances. The installation is dated and you will need to consider refurbishment. Costs have been provided below based on replacement with mid-range fixtures and fittings in similar locations.

Potential ACM to the ceiling

Kitchen installation is dated

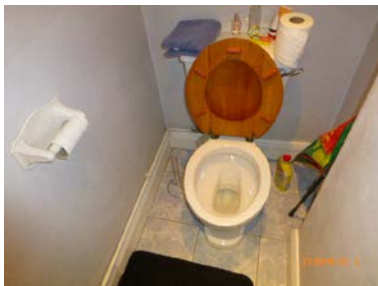
There was staining and discolouration to the low level walls behind the WC. Moisture readings were taken in this area and none of the readings were high or abnormal. We are of the opinion that this staining and discolouration relates to an historical escape of water.

Damp staining to walls

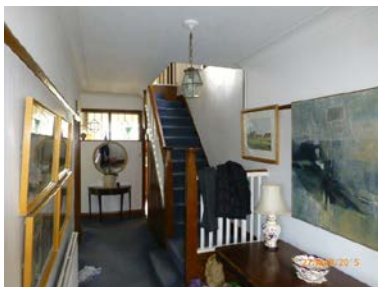
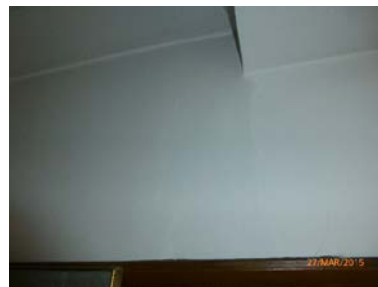
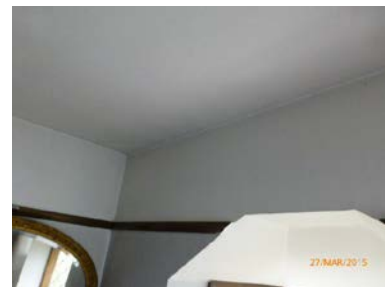
**Details/Defects/Issues:** Cracking was observed to the walls and ceiling of the hallway and to the landing ceiling. None of the cracks suggest significant building movement or distortion and are more likely the result of general settlement and expansion.

Cracks to the walls and ceiling of the hallway

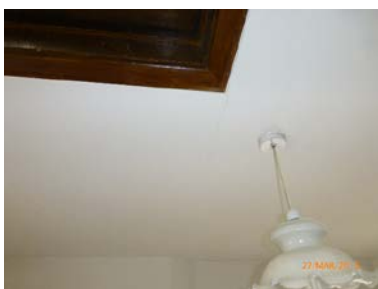
Crack to landing ceiling

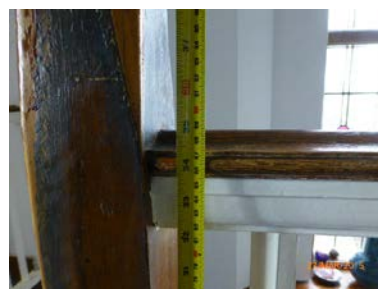
The handrails to the stairs do not comply with current Building Regulations. Approved Document K of The Building Regulations 2010 advises that in all buildings handrail height should be between 900-1000mm measured to the top of the handrail from the pitch line or floor. Handrails can form the top of a guarding if the height can be matched.

Landing hand rails are low

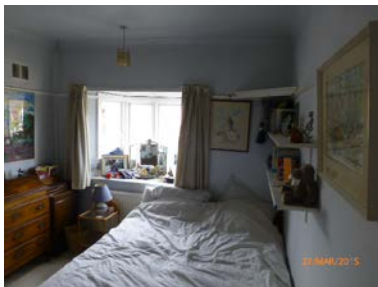
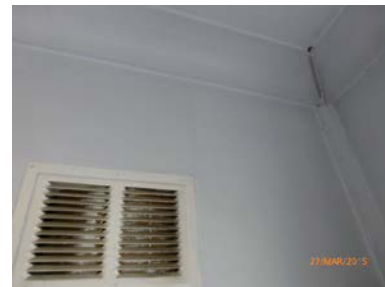
**Details/Defects/Issues:** Cracking was observed to the ceiling, walls and coving. None of the cracks suggest significant building movement or distortion and are more likely the result of general settlement and expansion.

Cracks to the walls and ceiling

The decoration and finishing is poor. The only way to address this issue would be to redecorate the walls, ceiling and woodwork. This should also include any additional preparation works to poorly finished surfaces such as cornices or woodwork. It would also be advisable to apply "Wallrock" fibrous paper to defective wall or ceiling surfaces prior to redecoration.

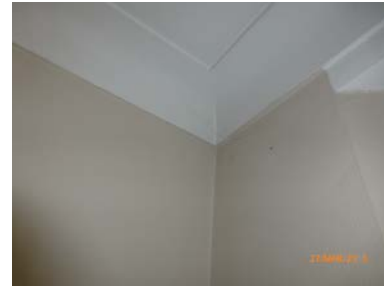
**Details/Defects/Issues:** Cracking was observed to the walls, ceiling and coving. None of the cracks suggest significant building movement or distortion and are more likely the result of general settlement and expansion.

Cracks to the walls, coving and ceiling

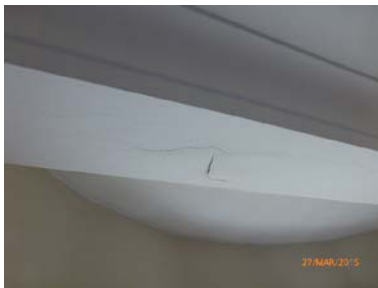
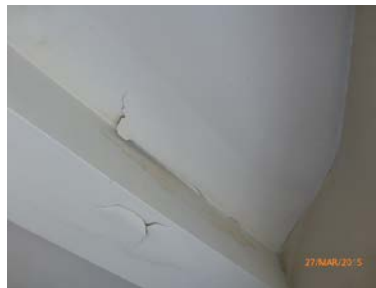
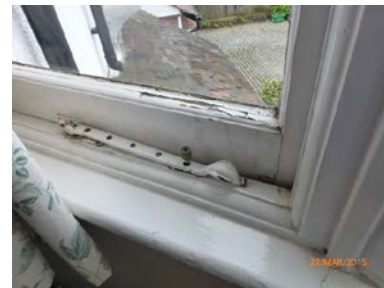
Staining was observed to the drop down beam to the front bay window which we believe relates to the defective roof covering advised later in the report. Prior to decoration the affected areas should be treated with an alkaline based sealer to prevent re-staining.

Water damage and staining to the drop down beam

Decoration to the windows is poor

The decoration to the windows is poor and the paint is flaking and blistering. The only effective way to address the issue, if the windows are not to be replaced, is to completely overhaul the windows and door by burning off loose and defective paintwork, applying bare wood primer to any exposed timber and re-finishing in undercoat and gloss paint. Costs for this work have been separated below.

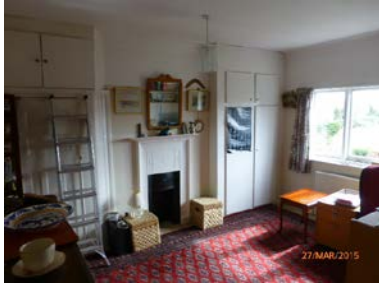
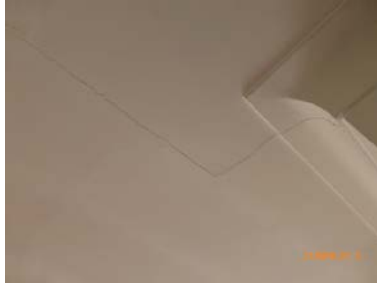
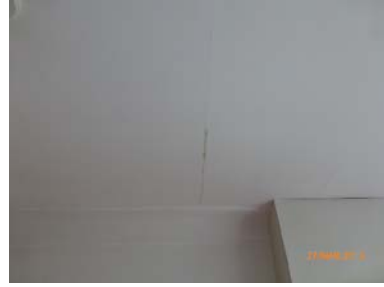
**Details/Defects/Issues:** Cracking was observed to the ceiling and coving. None of the cracks suggest significant building movement or distortion and are more likely the result of general settlement and expansion.

Cracks to the ceiling and coving

The decoration and finishing is poor. The only way to address this issue would be to redecorate the walls, ceiling and woodwork. This should also include any additional preparation works to poorly finished surfaces such as cornices or woodwork. It would also be advisable to apply "Wallrock" fibrous paper to defective wall or ceiling surfaces prior to redecoration.

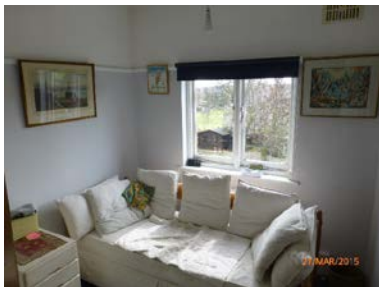
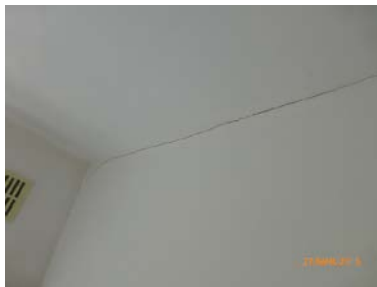
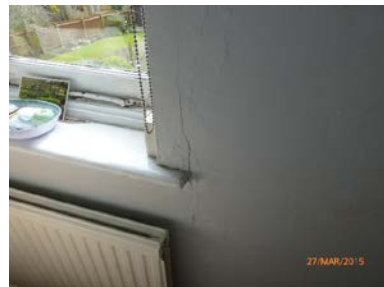
Cracking was observed to the ceiling and the ceiling line and wall to the right side of the rear facing window. None of the cracks suggest significant building movement or distortion and are more likely the result of general settlement and expansion.

Cracks to the ceiling line

Cracks to the wall

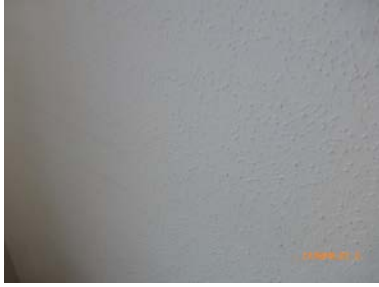
**Details/Defects/Issues:** The walls are covered with a textured coating which is a potential asbestos containing material (ACM). Further information in regard to potential asbestos containing materials is provided later in the report.

Wall have a textured coating

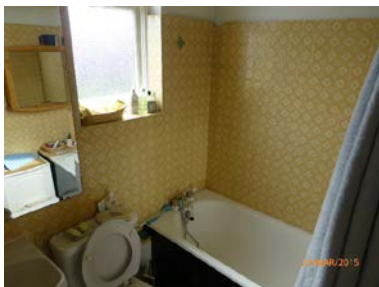
**Details/Defects/Issues:** The bathroom comprises of a floor standing bath, WC and wash hand basin and pedestal. The walls are covered with ceramic tiles. The installation is dated and you will need to consider refurbishment including replacement of sanitary fittings and wall tiles. Costs have been provided below on an important basis based on replacement with mid-range fixtures and fittings in the same locations.

Installation is dated

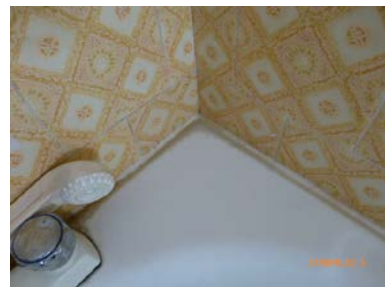
Wall tiling and sealant are in a poor state of repair

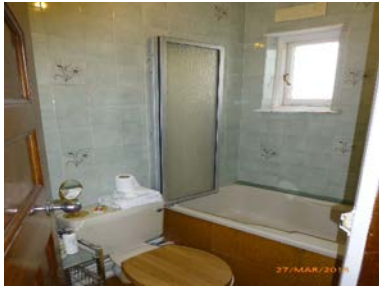
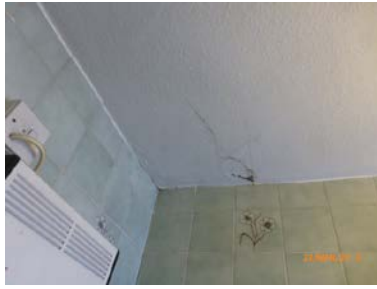
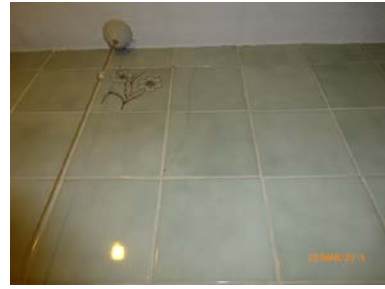
There is damage to the ceiling which will need to be cut out and patch repaired prior to complete redecoration.

Cracking was observed to the wall tile to the right side of the light pull cord. None of the cracks suggest significant building movement or distortion and are more likely the result of general settlement and expansion.

Damage to the ceiling

Crack to the wall tiles

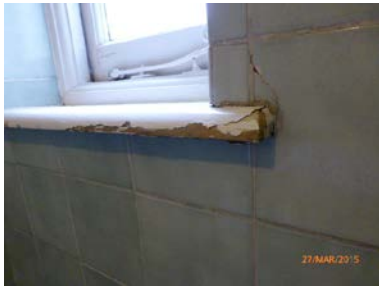
The window sill is located within the shower area and is exposed to water. As a result the paint finish has significantly deteriorated leaving exposed timber. If the shower set up is to remain in the same position then the window sill will need to be removed and replaced with a waterproof material such as uPVC.

Sill in shower is water damaged

Sealant to the bath is poor

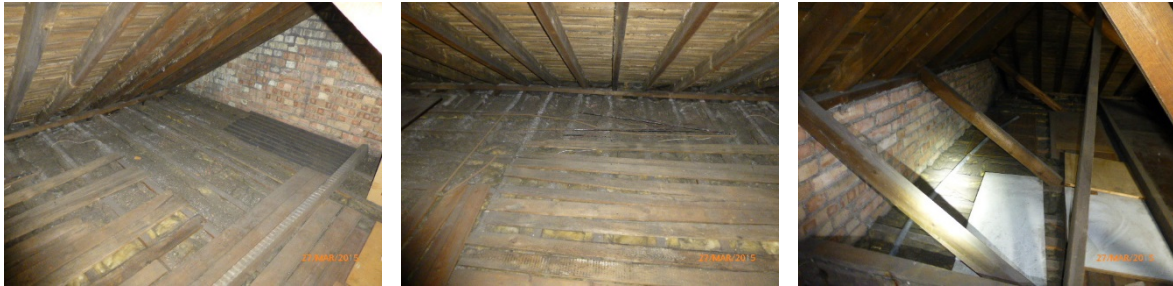
**Details/Defects/Issues:** The insulation to the loft space is inadequate. Approved Document L1B of The Building Regulations 2010 advises an insulation thickness of a minimum 270mm over the entire roof area with an allowance at the eaves for continuous airflow. This should also include insulation to the loft hatch in the form of compressed foam or similar.

Insulation in the loft space is inadequate

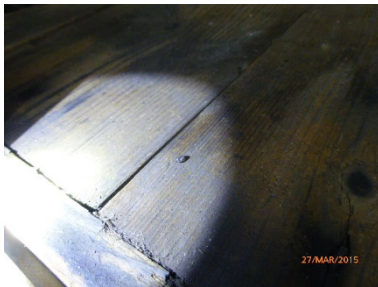
**Details/Defects/Issues:** Rodent droppings were observed in the roof space. You should instruct a specialist contractor as soon as practicable after completion to attend and eradicate the issue as this type of infestation can cause significant damage to the electrical, plumbing and fabric of the building if left unchecked.

Rodent droppings in the roof space

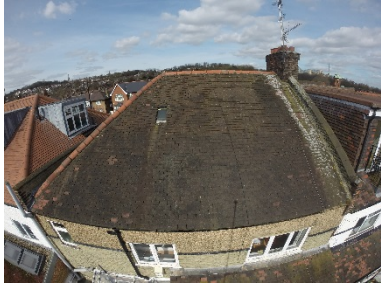
Rear roof slope

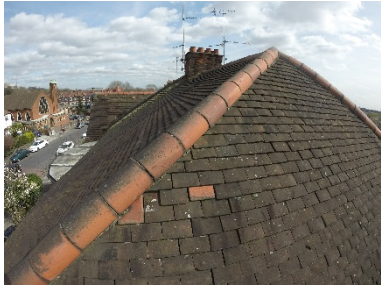
Damaged/missing/slipped tiles

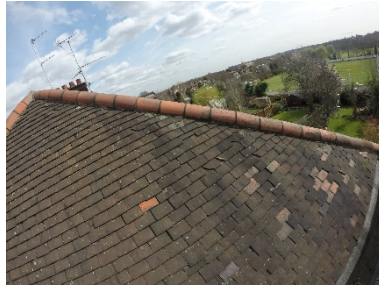
Mortar to the hip/ridge tiles is poor

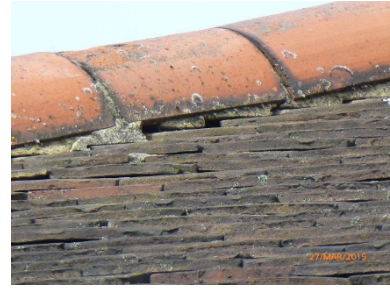
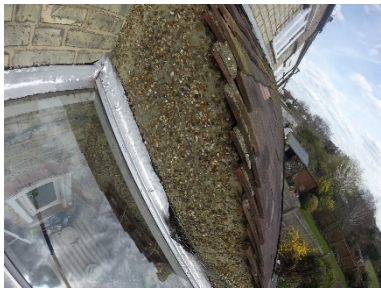
Verge tiling is loose and defective

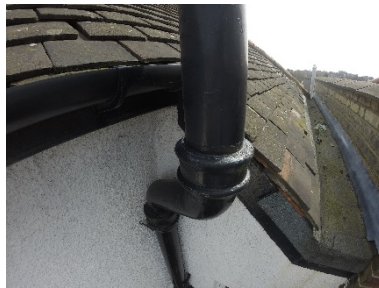
Cracked mortar to box gutter flashing Cement fillets to all edges and abutments are poor

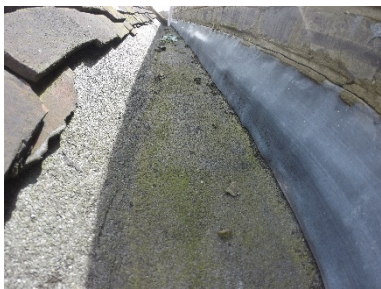
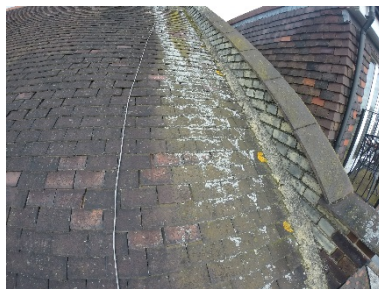
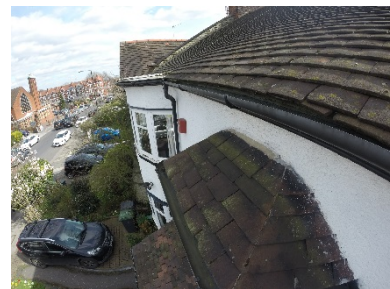
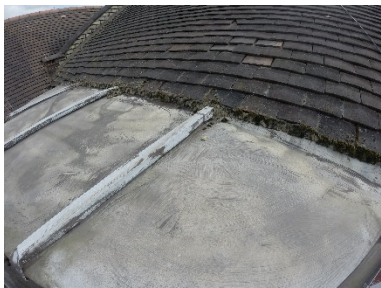
Front bay window roof is worn

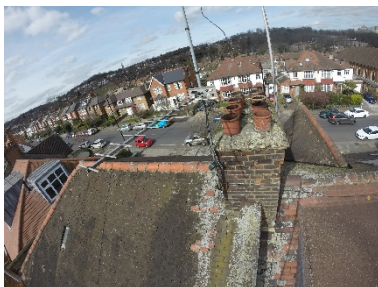
Poor flaunching

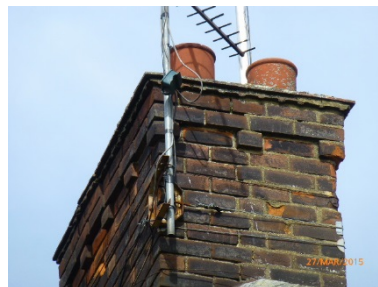
Spalled bricks and loose pointing

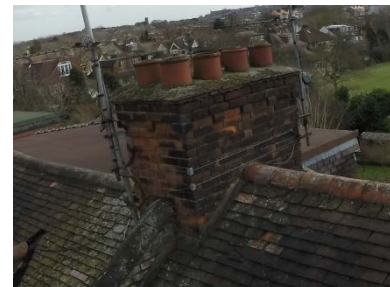
Open chimney flues

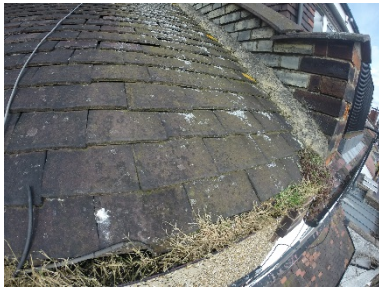
Gutters are blocked with leaves, moss and debris

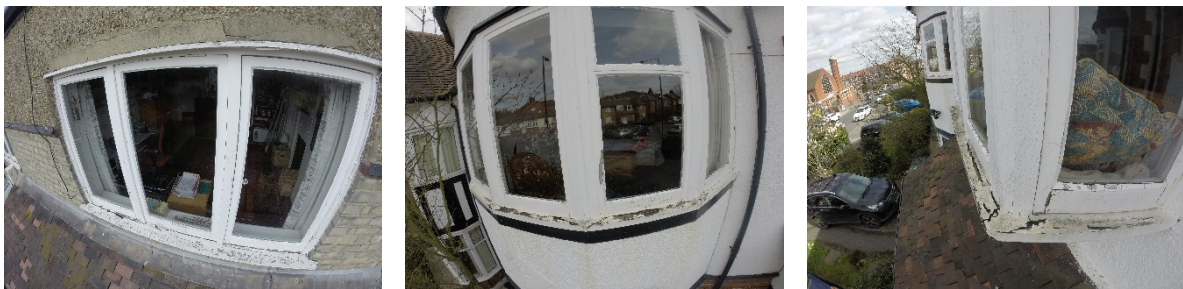
Window frames are in a poor state of repair

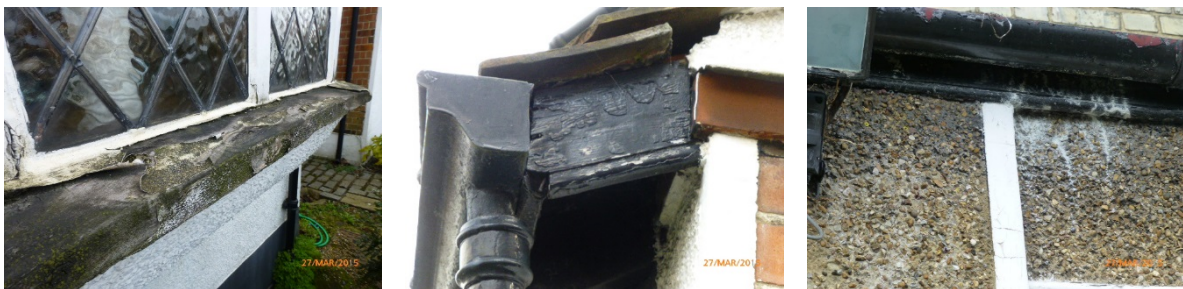
External window frames are poor

Soffit/eaves/fascia boards are in a poor state of repair

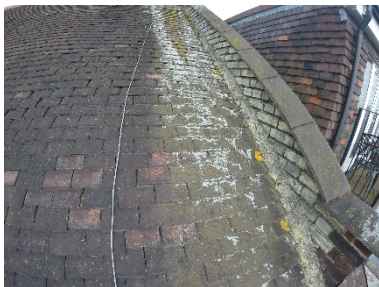
Pointing to the brickwork of the parapet walls is poor

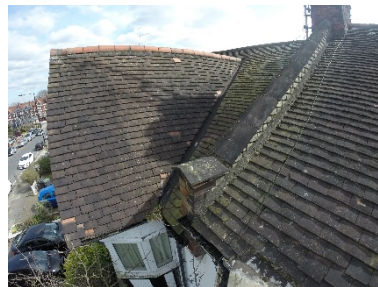
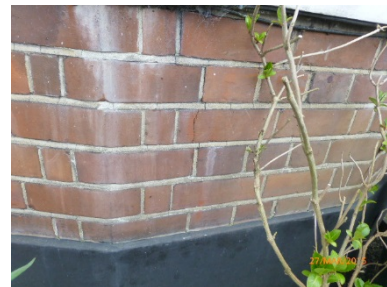
Crack to the left side of the bay

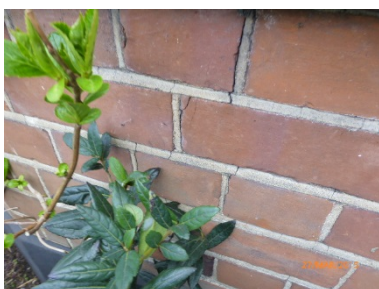
Crack to the centre of the bay

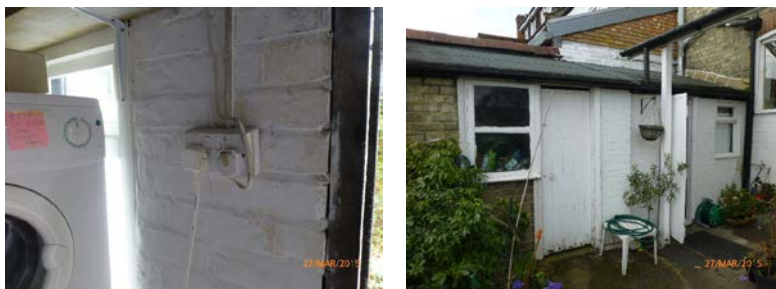
Power and lighting to the sheds should be checked

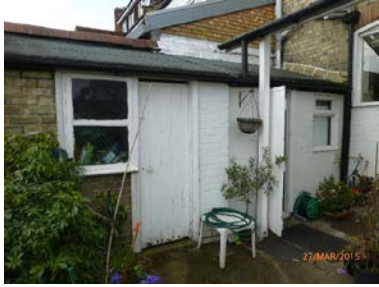
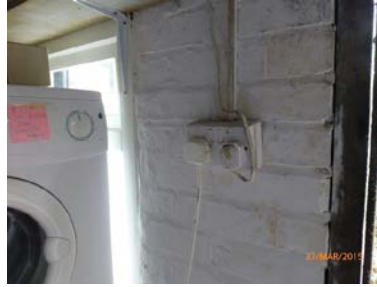
**Details/Defects/Issues:** There are two brick built outbuildings to the rear finished with a mono pitched roof. The roof is covered with felt. As advised earlier in the report the electrical installation should be checked and upgraded in lien with Approved Document P of The Building Regulations 2010.

Electrical installation to be checked

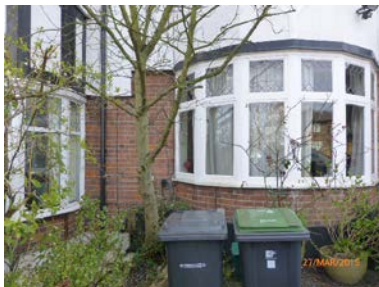
**Details/Defects/Issues:** There is a tree planted in close proximity to the left side of the front facing bay window and to the rear there are a number of creeping plants growing around the single storey off-shoot. Trees and shrubs can cause damage to foundations and underground services such as drainage. Where there are trees or large shrubs in close proximity to the property it would be appropriate to draw up a programme of management to restrict future growth to prevent possible damage.

Tree to the left of the front bay
