home-approved®

your survey report

167 [REDACTED], Muswell Hill, London, N [REDACTED]

27 March 2015

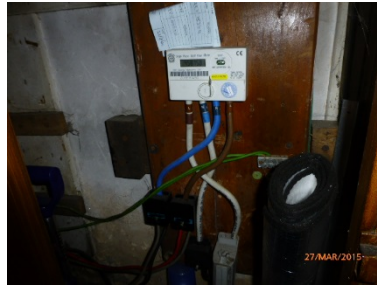
Main fuse and meter

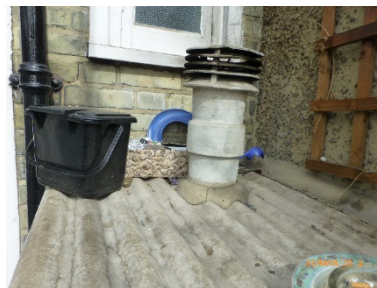
Flue through the roof

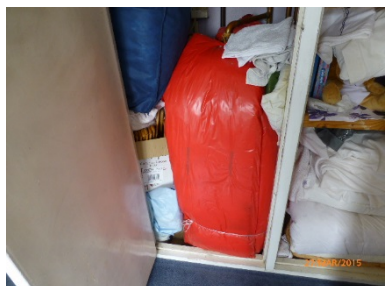
The hot water is produced by the gas fired boiler and is stored in the unlagged cylinder which is located in bedroom 5. The system is inadequate and should be updated in line with Approved Document G of The Building Regulations 2010.

Unlagged hot water cylinder

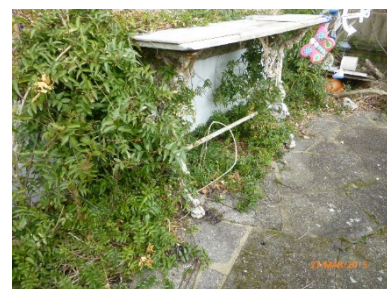
**Details/Defects/Issues:** There is a lack of ventilation to the suspended timber floor as there are only three air bricks to the front and none to the rear. The air bricks are too small and too few in number.

Small air bricks in the front wall

No air bricks to the rear

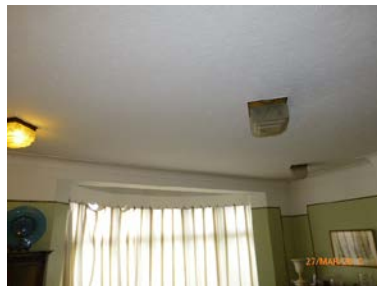
The ceiling is fitted with five light fittings, two of which were not working at the time of the inspection. A qualified electrician should attend and carry out repairs or replacements as necessary.

Lights not working

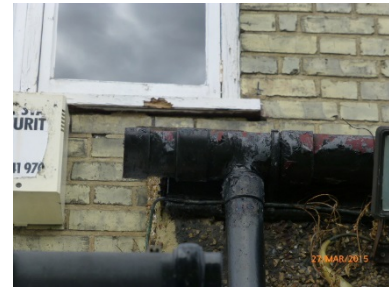
Decoration to rear gutters is poor

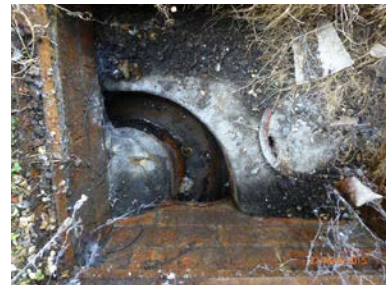
Inspection chamber is dirty
