home-approved®

your survey report

167 [REDACTED], Muswell Hill, London, N [REDACTED]

27 March 2015

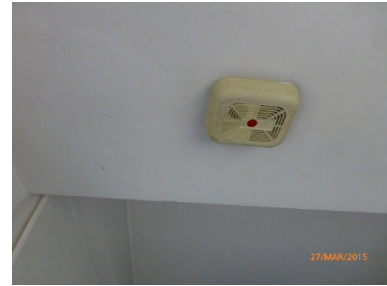
Battery powered smoke detection

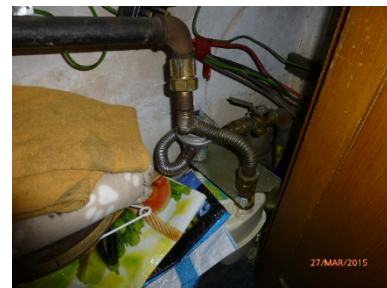
Gas meter

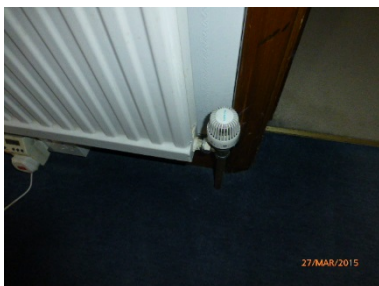
Thermostatic radiator valves

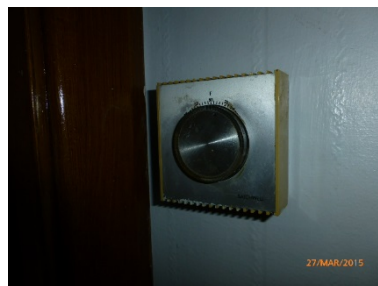
Thermostatic control

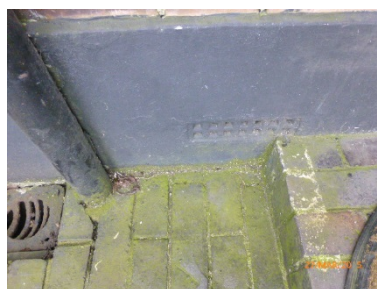
**Details/Defects/Issues:** There is a lack of ventilation to the suspended timber floor as there are only three air bricks to the front and none to the rear. The air bricks are too small and too few in number.

Small air bricks in the front wall

No air bricks to the rear

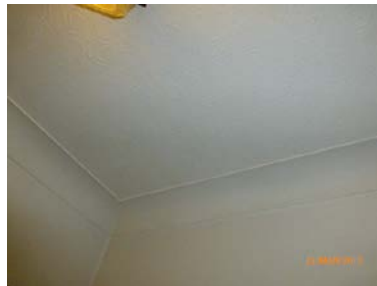
**Details/Defects/Issues:** Cracking was observed to the ceiling and the coving. There was also a small crack to the front facing bay window. None of the cracks suggest significant building movement or distortion and are more likely the result of general settlement and expansion.

Cracks to the ceiling and to the coving

The decoration and finishing is poor. The only way to address this issue would be to redecorate the walls, ceiling and woodwork. This should also include any additional preparation works to poorly finished surfaces such as cornices or woodwork. It would also be advisable to apply "Wallrock" fibrous paper to defective wall or ceiling surfaces prior to redecoration. 'Wallrock' is a non-woven material which is suitable for covering up untidy and poorly plastered surfaces including cracks.

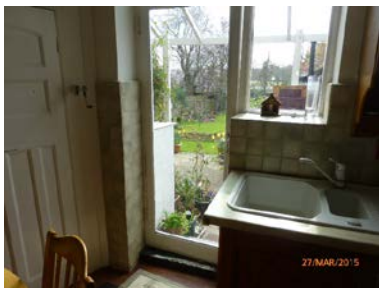
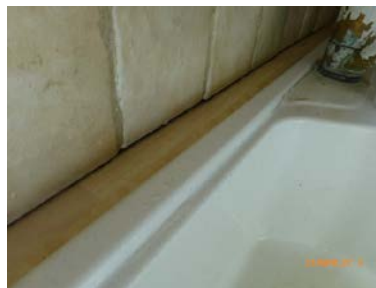
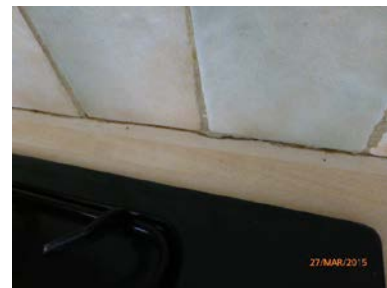
Kitchen installation is dated

Glass in a critical location

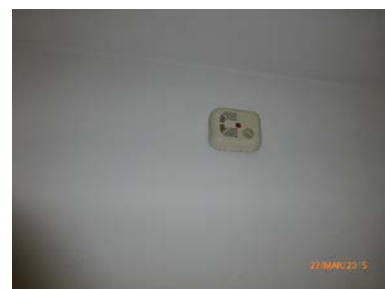
Battery powered smoke detection

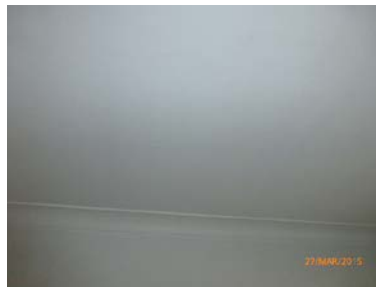
**Details/Defects/Issues:** Cracking was observed to the ceiling, walls and coving. None of the cracks suggest significant building movement or distortion and are more likely the result of general settlement and expansion.

Cracks to the walls and ceiling

The decoration and finishing is poor. The only way to address this issue would be to redecorate the walls, ceiling and woodwork. This should also include any additional preparation works to poorly finished surfaces such as cornices or woodwork. It would also be advisable to apply "Wallrock" fibrous paper to defective wall or ceiling surfaces prior to redecoration.

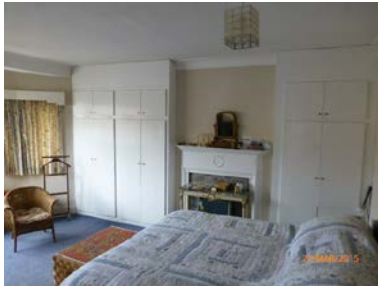
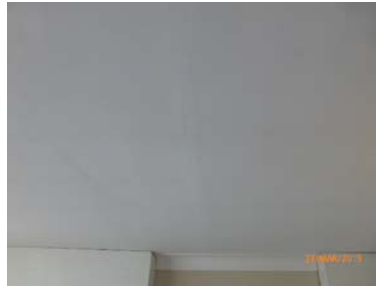
Cracks to the walls, coving and ceiling

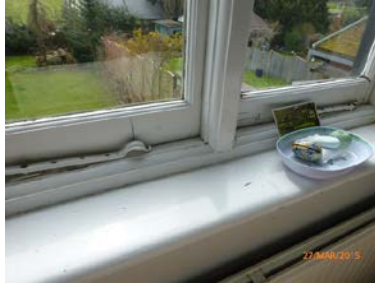
Decoration to the windows is poor

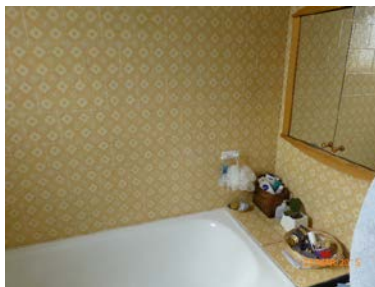
Wall tiling and sealant are in a poor state of repair

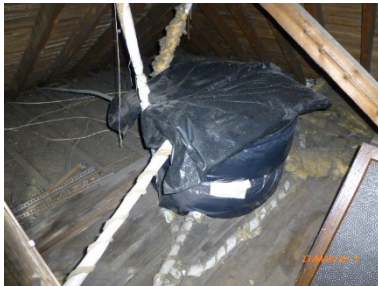
**Details/Defects/Issues:** The current cold water storage is not fitted with a Bye-law 30 kit and as a result the water is contaminated with dust and loft particles. A plumbing contractor should attend and drain down and sanitise the cold water tank and then re-fill. A Bye-law 30 kit should then be fitted to the cold water storage tank.

No bye-law 30 kits fitted to the water and expansion tanks

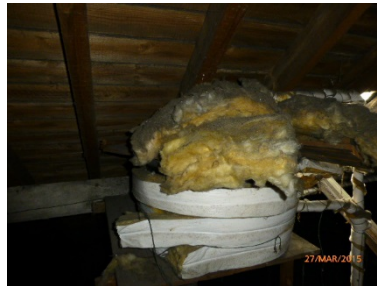
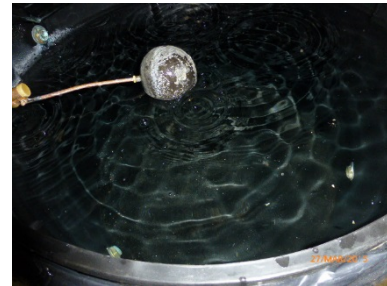
Water is contaminated

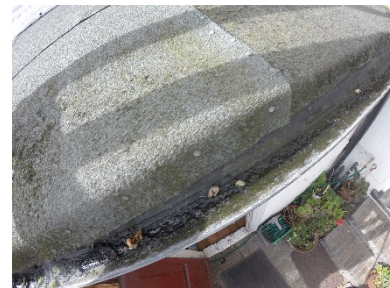
Rear shed roof is poorly felted and the flashing is poor

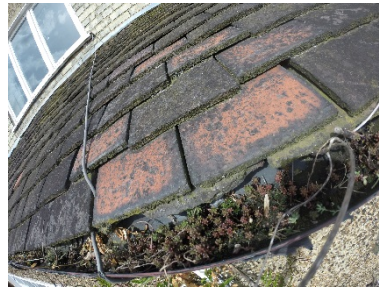
Decoration to rear gutters is poor

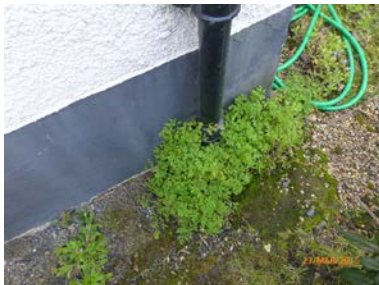
Leaking hopper

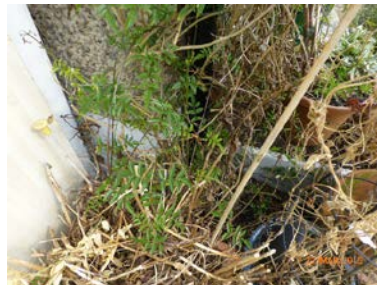
Hopper blocked by creeper

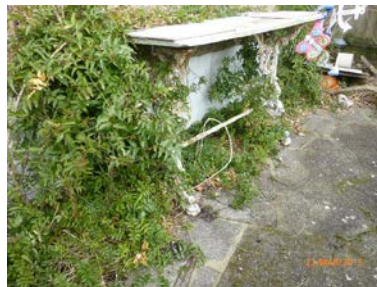
Creeper plants around the rear walls
